## MANUFACTURED HOMES

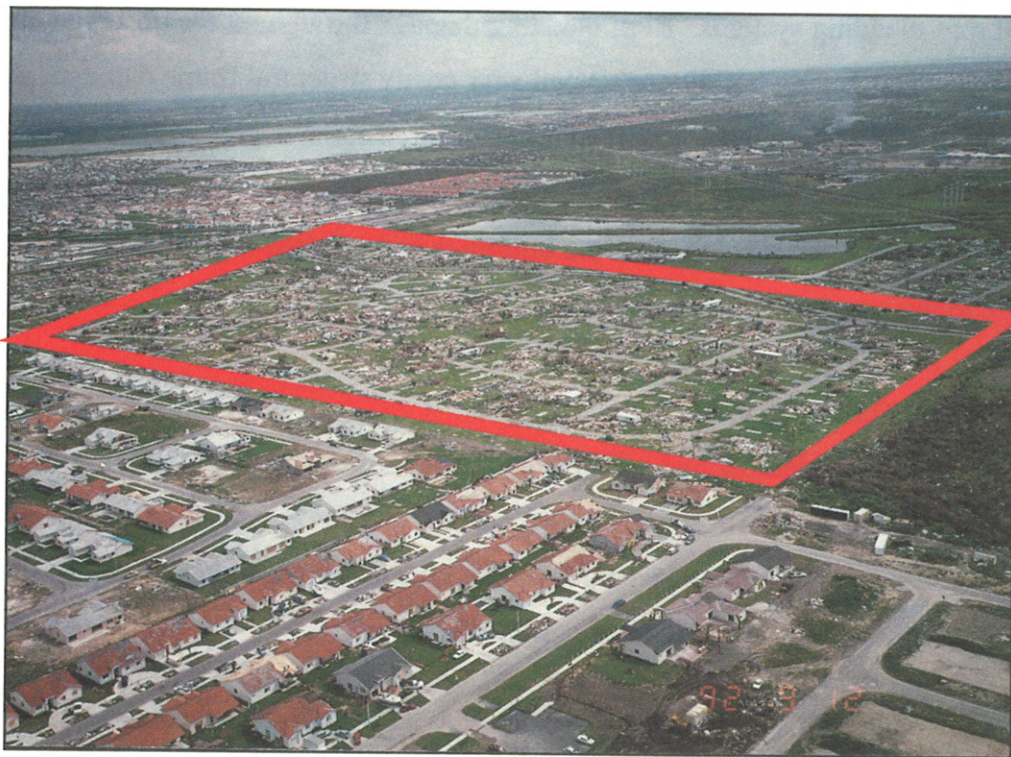
Manufactured homes possessed poor ability to withstand the high wind loads generated by Hurricane Andrew (SEE FIGURE 21). In several subdivisions, many of these homes suffered total losses.

FIGURE 21. *Aerial photo of damage area. Shows building performance difference between manufactured homes (outlined in center) and conventional residential buildings (lower left).*
